Manhole Inspection Summary

Manhole # S39G__043MH

Insp Date: **2/20/09 11:34 AM**

Location Address: **1023 WATSON ST**

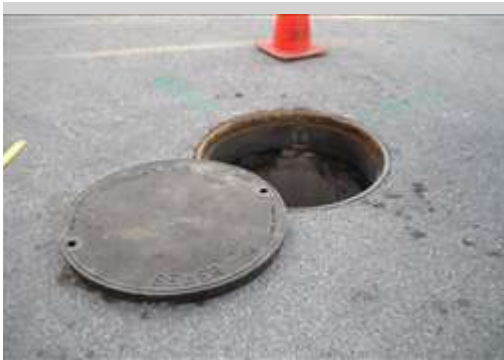
Miscellaneous

replaced previous lid with new 30"
sanitary

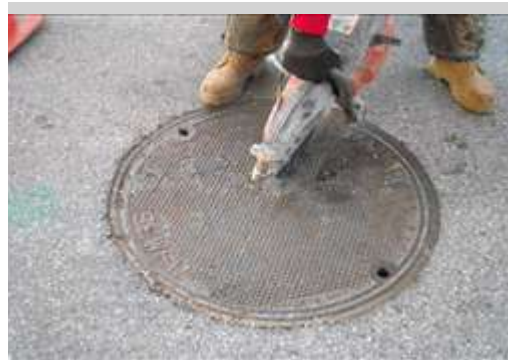
Miscellaneous

prior lid was sealed into frame and
required a saw to be cut out.

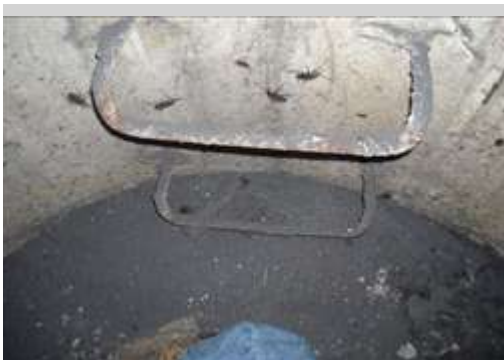
Defect 4

Condition: ☐ Sound ☐ Cracked ☐ Root Intrusion ☐ Deteriorated ☐ Leaks ☒ **Debris**

☒ **Corroded**

bench debris; stairs are corroded

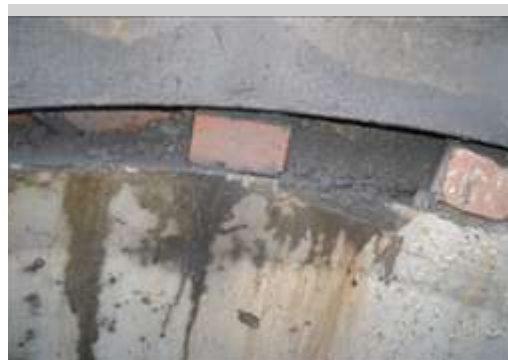
Defect 3

Condition: ☐ Sound ☐ Cracked ☐ Root Intrusion ☒ **Loose Brick** ☒ **Deteriorated**

Infiltration: ☐ None ☒ **Joint** ☐ Cracks ☐ Mortar ☐ Roots ☐ Wall

loose and missing bricks, evidence of
infiltration from frame/corbel joint

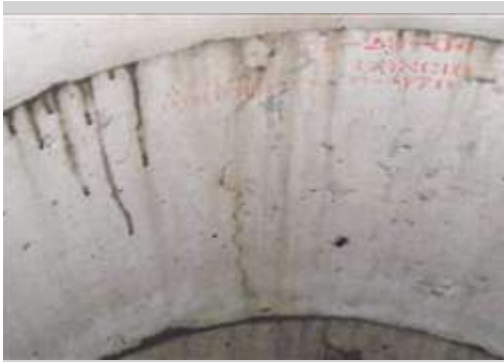
Defect 2

Condition: ☐ Sound ☒ **Cracked** ☐ Root Intrusion ☐ Loose Brick ☐ Deteriorated

Infiltration: ☐ None ☒ **Joint** ☐ Cracks ☐ Mortar ☐ Roots ☐ Wall

barrel joint leaks, also note large crack in center of photo

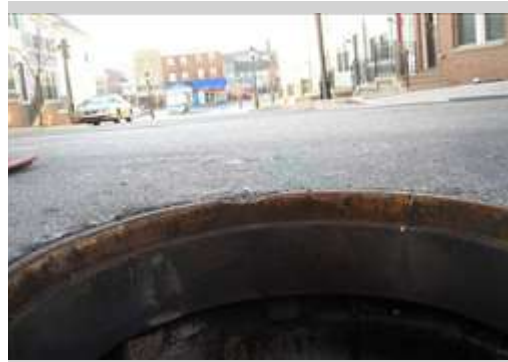
Defect 1

☒ **Cracked**

☒ **Leaks**

frame cracked, evidence of inflow due to sheeting from crown of roadway

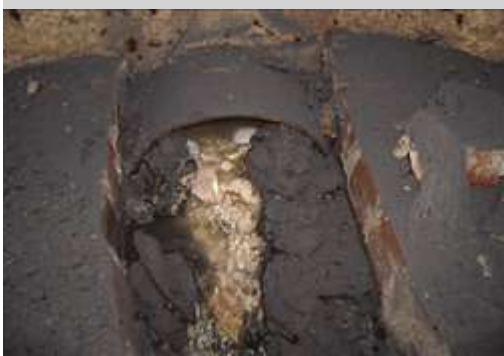
Defect 5

Condition: ☐ Sound ☐ Cracked ☐ Root Intrusion ☐ Deteriorated ☐ Leaks ☒ **Debris**

channel debris

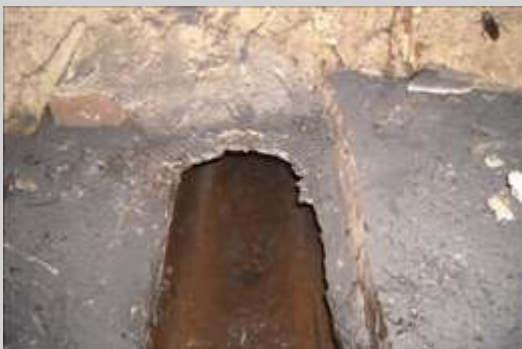
6 O'Clock Inflow

Pipe Height: **10.8** (in.) Rod and Bar (Angled)
Pipe Material: **Clay** ☐ Pipe Lined
Invert Depth: **9.97** (ft.) Flow Characteristics: **Slow**
Deposits: ☐ None ☐ Mud ☐ Sludge ☒ Debris ☐ Grease
Silt Depth: **2** (in.) Deposits Extent: **Light**
Infiltration: **None** Pipe Seal Cond: **Sound**

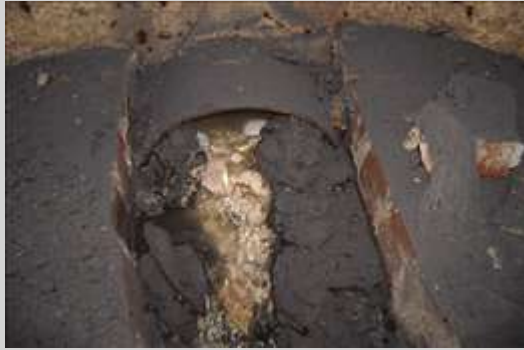
9 O'Clock Inflow

connection is almost fully closed due to grease and other debris

Deposits: ☐ None ☐ Mud ☐ Sludge ☒ **Debris** ☒ **Grease**

Silt Depth: **7.5** (in.) Deposits Extent: **Heavy**
